Inspection Report

Property Address:
123 America St
Tampa FL

House 2 Home Inspections Services Inc.

Date: 9/27/2018	Time: 01:30 PM	Report ID: 20180927-3023-Northfield-Dr
Property: 123 America St Tampa FL	Customer:	Real Estate Professional:

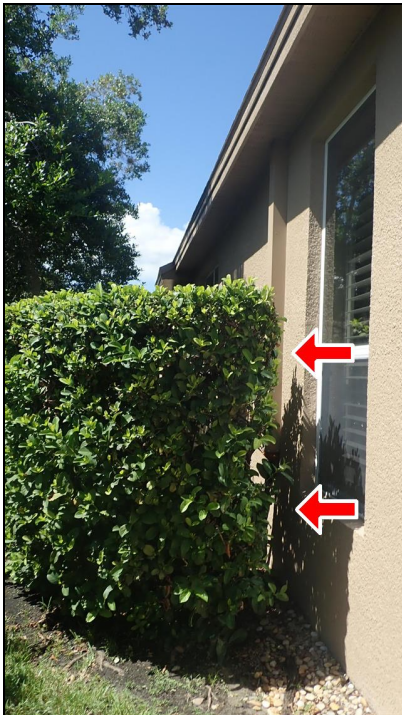
3.2 (1) The trees and shrubs on the property should be maintained to prevent overgrowth and encroachment onto and possible damage to the structure.

3.2 Item 1(Picture) Maintain shrubs trimmed back

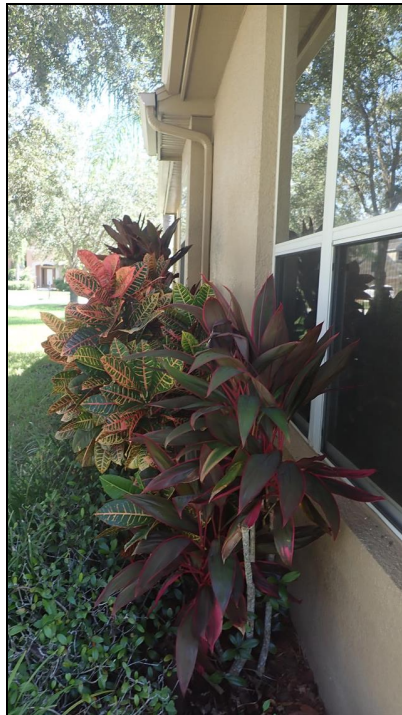
3.2 Item 2(Picture) Maintain shrubs trimmed back

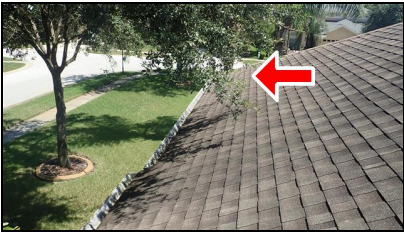
(2) Branches from the surrounding trees are overhanging the roof, or are in contact with the roof surface. This could damage (abrade) the roof surfaces and/or provide a route onto the roof and into the attic for insects and other pests. Nearby trees should be kept pruned.

3.2 Item 3(Picture) Trim back branches

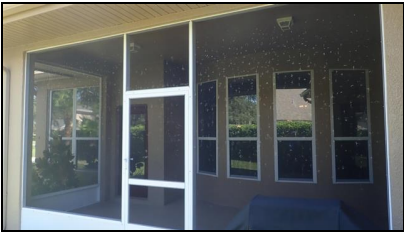
3.5 The screens at the rear patio have signs of some type of white debris stuck to them. We recommend you have a qualified technician further evaluate and clean as needed.

3.5 Item 1(Picture) Screened in rear patio

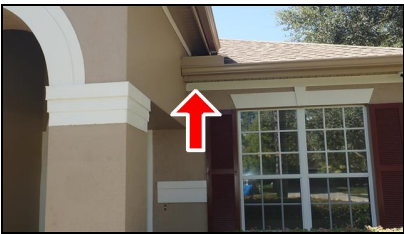
3.10 Repair the area of wood decay at the fascia boards at a few areas around the roof. We recommend you have a qualified technician further evaluate and advice. Replacement of affected materials is considered the best solution for long term performance of repair and plastic moldings are available for even better protection - (Contractor should review for additional damage and probe where suspect to insure that all damage is identified and replaced). Fillers are discouraged but are commonly used in repairs of smaller areas where replacement would be difficult. Fillers should be done by experienced tradesmen and warrantee for a reasonable length of time. Be sure to caulk, prime, and paint these areas once the repairs are complete to prevent recurrence and to match existing finishes.

3.10 Item 1(Picture) wood decay

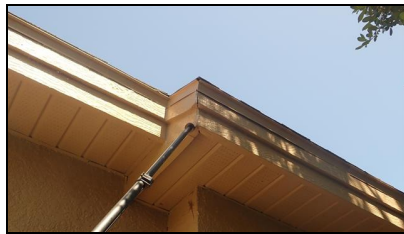
3.10 Item 2(Picture) Wood decay

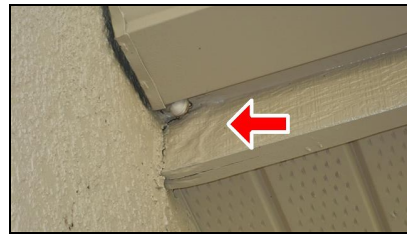
3.10 Item 3(Picture) Wood decay

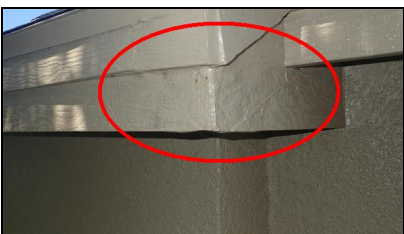
3.10 Item 4(Picture) Wood decay

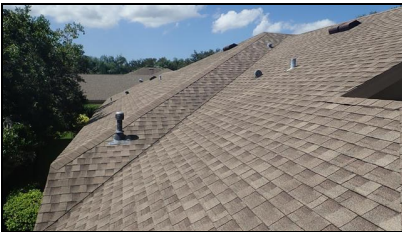
4.2 (1) The roof surfaces are showing some signs of age and appear to be past mid life. There is typical to heavy granular loss across the roof's surface. We recommend you have a qualified roofing technician further evaluate and advice on any necessary roofing repairs.

4.2 Item 1(Picture) Roof mid life

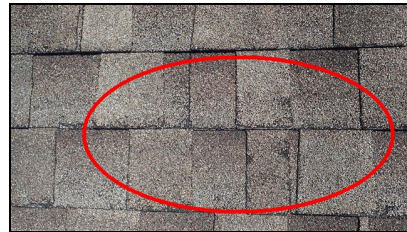
4.2 Item 3(Picture) Granular loss

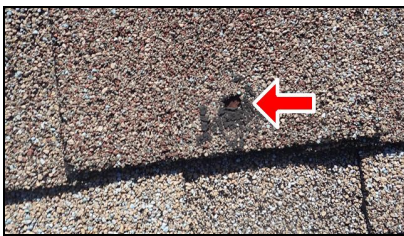
(2) There are a few scattered locations on the roof surfaces where the roofing nails in the shingles were either driven in crooked when installed or have started to back out of the roof sheathing due to changes in temperature and expansion and contraction of the materials. These nails are now "popping" through the shingle surface and repair is needed to prevent water intrusion and damage. Any exposed fastener is a leak source. The only practical cure (short of replacing the affected shingles) is to hammer down the nail and seal over the exposed fasteners. A qualified roofing contractor should do the job. The sealant typically needs to be monitored and renewed as needed to lessen the likelihood of leaks.

4.2 Item 7(Picture) Nail pop

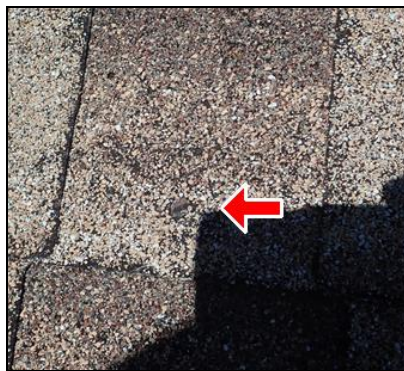
4.2 Item 8(Picture) Nail pop

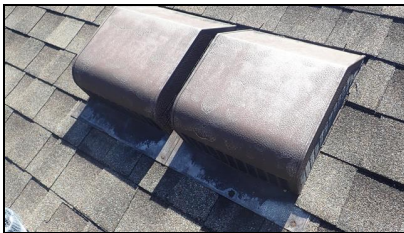
4.5 The nails that attach the off ridge vent to the roof are galvanized, however, many of the nails are already rusting and corroding. I recommend the application of roofing tar or silicone caulk over these nail heads to prevent them from corroding and so they will last the life of the roof.

4.5 Item 1(Picture) Off ridge vent

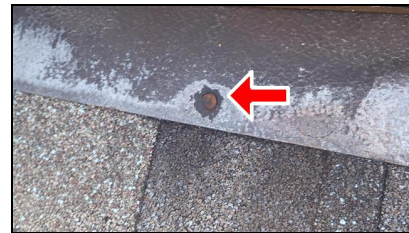
4.5 Item 3(Picture) Rusted vent nail

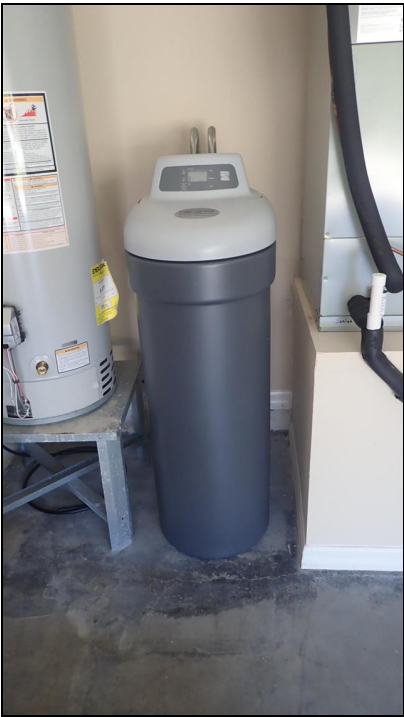
(3) Water treatment equipment (filter &/or softener) has been added to the main water delivery system. Evaluation of this equipment is outside the scope of this inspection. You should contact the company that installed or services the equipment, or if not available, contact a reputable water treatment company for evaluation and explanation of its features and benefits.

5.1 Item 1(Picture) Water softener beyond inspection

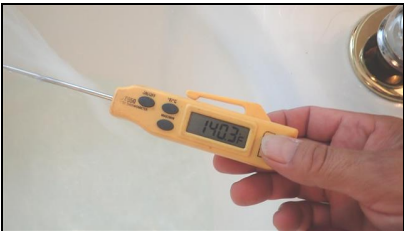
(2) The temperature on the water heater is turned up past the factory setting of around 120 degrees. The time to scald is significantly reduced as the temperature setting on the unit is increased. Also, if the temperature is turned up too high, it may cause leakage from the temperature and pressure relief valve. Upon ownership, you should evaluate and adjust the temperature setting on the water heater to meet your personal needs and to maximize energy efficiency and personal safety.

5.8 Item 2(Picture) Water
temperature above 120 degrees

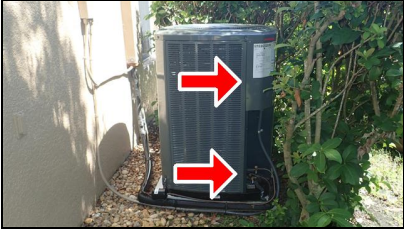
7.2 The shrubs are too close to the air conditioning condenser unit. These units require adequate airflow across the coils to efficiently exchange temperature from the warmed refrigerant as it passes through the tubing inside. Vegetation that is allowed to grow too close to or onto the condenser housing impedes airflow, and can contribute to damage and

inefficient operation of the system. Vegetation should be kept trimmed back at least 12 inches away from all sides of the condenser housing.

7.2 Item 1(Picture) Trim back shrubs

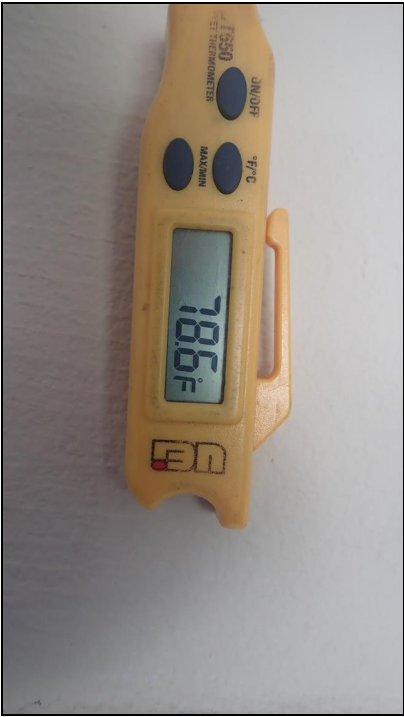
7.5 An ambient air test was performed on the cooling system to determine if the difference in temperatures of the supply and return air are between 15 degrees and 21 degrees, which indicates that the unit is cooling within industry standards. The return air temperature on the system was 78.6 degrees, and the supply air temperature was 53.4 degrees. For a temperature differential of 25.2 degrees. This indicates that the unit is **not cooling within standards** and may not be working properly. A licensed Heat/Air contractor should further evaluate the system and advise.

7.5 Item 1(Picture) Air return temperature

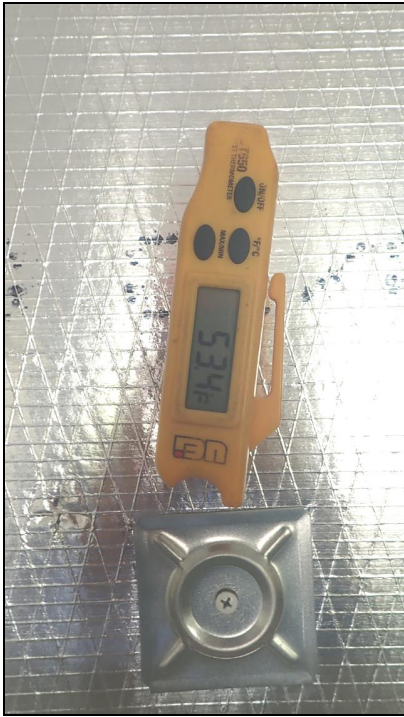
7.5 Item 2(Picture) Air supply temperature

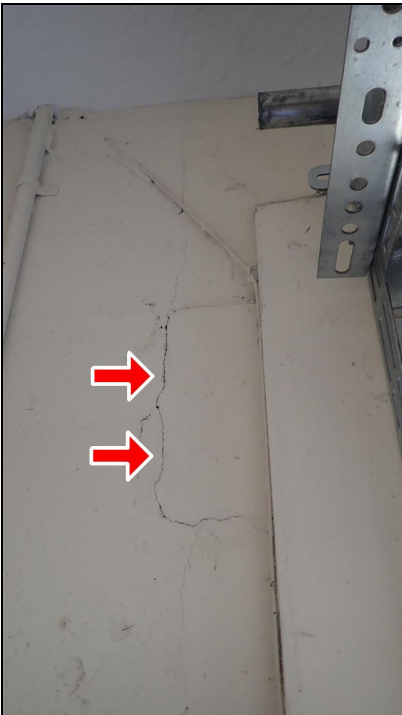
9.7 Minor cracking is evident in the garage wall, but there is no noticeable vertical displacement or evidence of significant settlement. The crack appears to be typical for this type of construction.

9.7 Item 1(Picture) Typical crack at garage wall

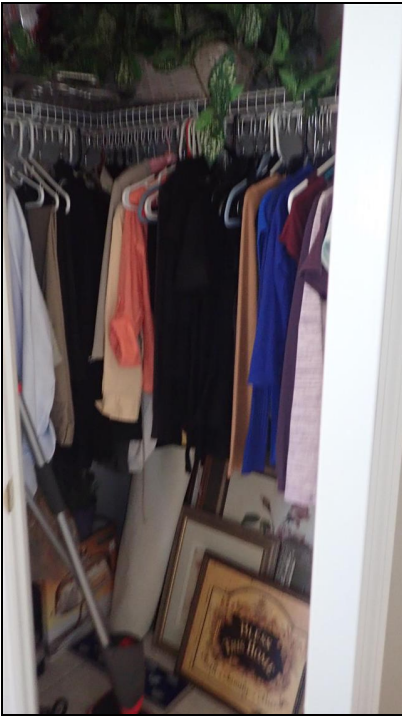
10.7 Personal goods stored in closets prevented access to inspection of all features contained in them. We suggest further inspection of these areas during your final walk through.

10.7 Item 1(Picture) Stored items in closet

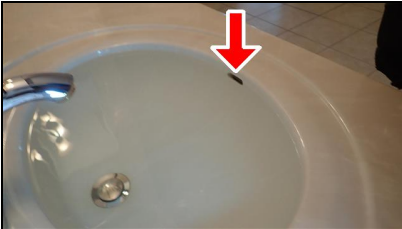
12.2 The overflow drain on the wash basin is clogged. The drain should be cleared. A qualified technician could do the work.

12.2 Item 1(Picture) Clogged over flow

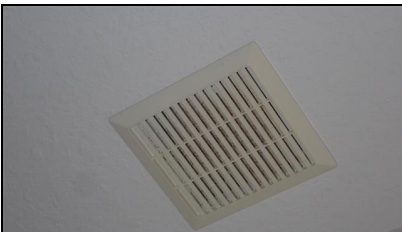
12.7 The bath vent covers and fan blades are covered with accumulated dust. Cleaning of the units will improve function.

12.7 Item 1(Picture) Clean bathroom vents

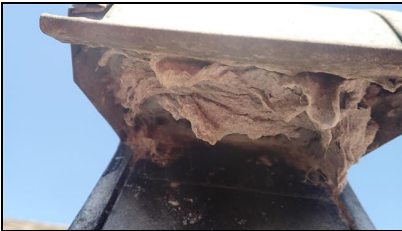
13.3 The dryer vent hood on the roof is very clogged with lint which is significantly restricting the air flow and operation of any vent flap. Have a professional duct cleaning service clean the hood, and since the vent has been restricted for an unknown period of time, they should also clean the entire vent system, flexible vent hose behind the dryer, and check the vent port on the dryer itself to insure that there is proper air flow and operation of the dryer and to eliminate a fire hazard. Then, be sure to clean and maintain the lint build-up from the dryer vent hood on a regular basis (time between cleaning depends on individual use) to allow proper air flow and operation of the dryer. Improper maintenance of the dryer vent hood can create a fire hazard

13.3 Item 1(Picture) Clean dryer vent hood

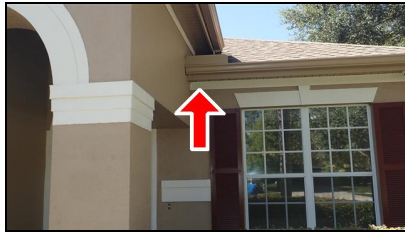
Repair the area of wood decay at the fascia boards at a few areas around the roof. We recommend you have a qualified technician further evaluate and advice. Replacement of affected materials is considered the best solution for long term performance of repair and plastic moldings are available for even better protection - (Contractor should review for additional damage and probe where suspect to insure that all damage is identified and replaced). Fillers are discouraged but are commonly used in repairs of smaller areas where replacement would be difficult. Fillers should be done by experienced tradesmen and warrantee for a reasonable length of time. Be sure to caulk, prime, and paint these areas once the repairs are complete to prevent recurrence and to match existing finishes.

3.10 Item 1(Picture) wood decay

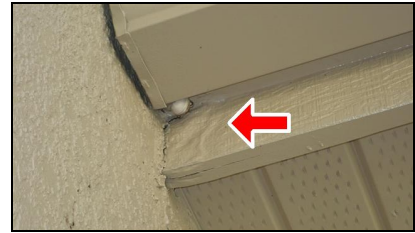
3.10 Item 3(Picture) Wood decay

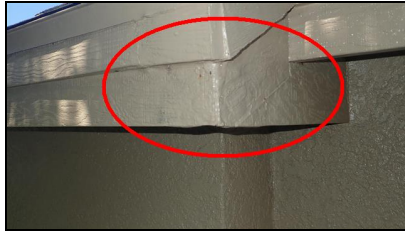
3.10 Item 4(Picture) Wood decay

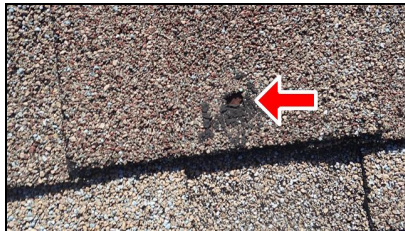
(2) There are a few scattered locations on the roof surfaces where the roofing nails in the shingles were either driven in crooked when installed or have started to back out of the roof sheathing due to changes in temperature and expansion and contraction of the materials. These nails are now "popping" through the shingle surface and repair is needed to prevent water intrusion and damage. Any exposed fastener is a leak source. The only practical cure (short of replacing the affected shingles) is to hammer down the nail and seal over the exposed fasteners. A qualified roofing contractor should do the job. The sealant typically needs to be monitored and renewed as needed to lessen the likelihood of leaks.

4.2 Item 7(Picture) Nail pop

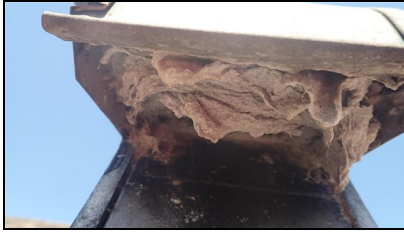
The dryer vent hood on the roof is very clogged with lint which is significantly restricting the air flow and operation of any vent flap. Have a professional duct cleaning service clean the hood, and since the vent has been restricted for an unknown period of time, they should also clean the entire vent system, flexible vent hose behind the dryer, and check the vent port on the dryer itself to insure that there is proper air flow and operation of the dryer and to eliminate a fire hazard. Then, be sure to clean and maintain the lint build-up from the dryer vent hood on a regular basis (time between cleaning depends on individual use) to allow proper air flow and operation of the dryer. Improper maintenance of the dryer vent hood can create a fire hazard

13.3 Item 1(Picture) Clean dryer vent hood

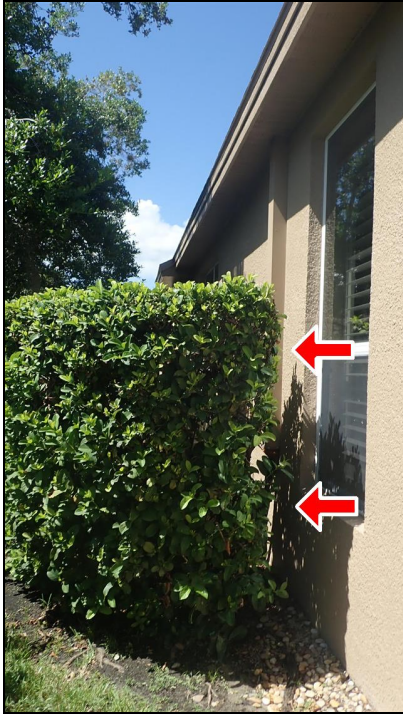
(1) The trees and shrubs on the property should be maintained to prevent overgrowth and encroachment onto and possible damage to the structure.

3.2 Item 1(Picture) Maintain shrubs trimmed back

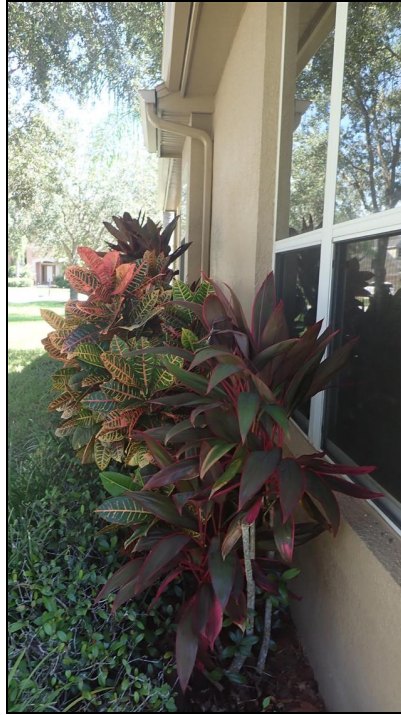
3.2 Item 2(Picture) Maintain shrubs trimmed back

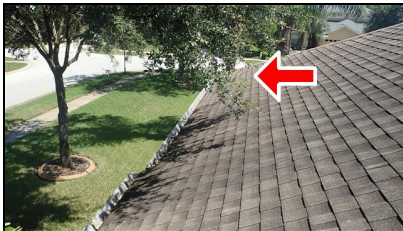
(2) Branches from the surrounding trees are overhanging the roof, or are in contact with the roof surface. This could damage (abrade) the roof surfaces and/or provide a route onto the roof and into the attic for insects and other pests. Nearby trees should be kept pruned.

3.2 Item 3(Picture) Trim back branches

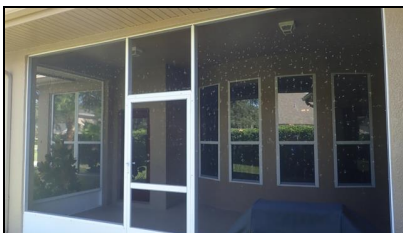
The screens at the rear patio have signs of some type of white debris stuck to them. We recommend you have a qualified technician further evaluate and clean as needed.

3.5 Item 1(Picture) Screened in rear patio

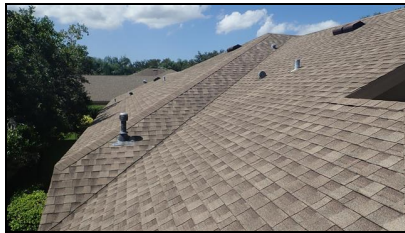
(1) The roof surfaces are showing some signs of age and appear to be past mid life. There is typical to heavy granular loss across the roof's surface. We recommend you have a qualified roofing technician further evaluate and advice on any necessary roofing repairs.

4.2 Item 1(Picture) Roof mid life

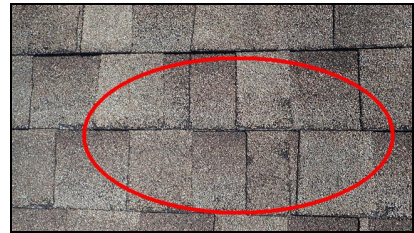
4.2 Item 3(Picture) Granular loss

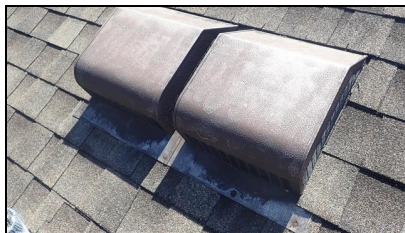
The nails that attach the off ridge vent to the roof are galvanized, however, many of the nails are already rusting and corroding. I recommend the application of roofing tar or silicone caulk over these nail heads to prevent them from corroding and so they will last the life of the roof.

4.5 Item 1(Picture) Off ridge vent

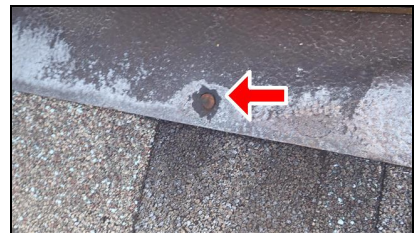
4.5 Item 3(Picture) Rusty vent nail

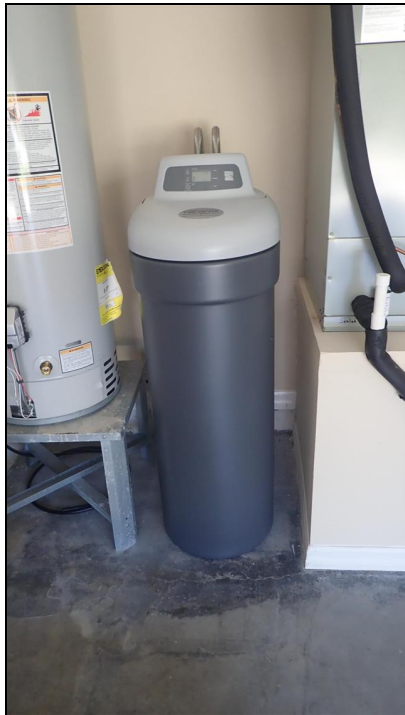
equipment, or if not available, contact a reputable water treatment company for evaluation and explanation of its features and benefits.

5.1 Item 1(Picture) Water softener beyond inspection

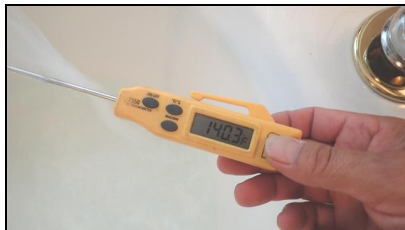
(2) The temperature on the water heater is turned up past the factory setting of around 120 degrees. The time to scald is significantly reduced as the temperature setting on the unit is increased. Also, if the temperature is turned up too high, it may cause leakage from the temperature and pressure relief valve. Upon ownership, you should evaluate and adjust the temperature setting on the water heater to meet your personal needs and to maximize energy efficiency and personal safety.

5.8 Item 2(Picture) Water temperature above 120 degrees

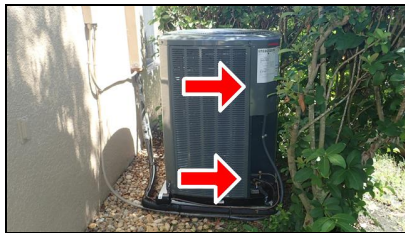
The shrubs are too close to the air conditioning condenser unit. These units require adequate airflow across the coils to efficiently exchange temperature from the warmed refrigerant as it passes through the tubing inside. Vegetation that is allowed to grow too close to or onto the condenser housing impedes airflow, and can contribute to damage and inefficient operation of the system. Vegetation should be kept trimmed back at least 12 inches away from all sides of the condenser housing.

7.2 Item 1(Picture) Trim back shrubs

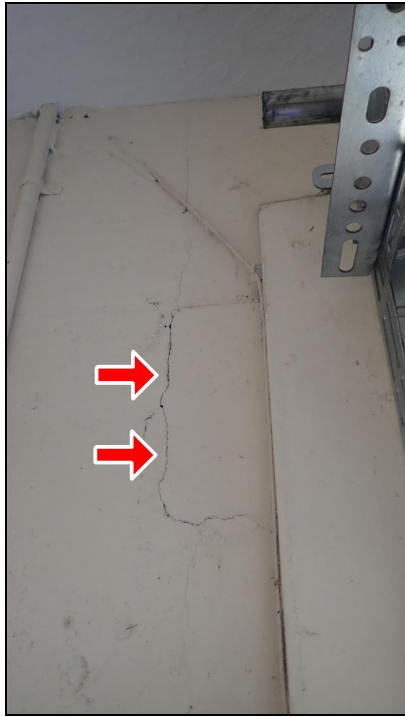
Minor cracking is evident in the garage wall, but there is no noticeable vertical displacement or evidence of significant settlement. The crack appears to be typical for this type of construction.

9.7 Item 1(Picture) Typical crack at garage wall

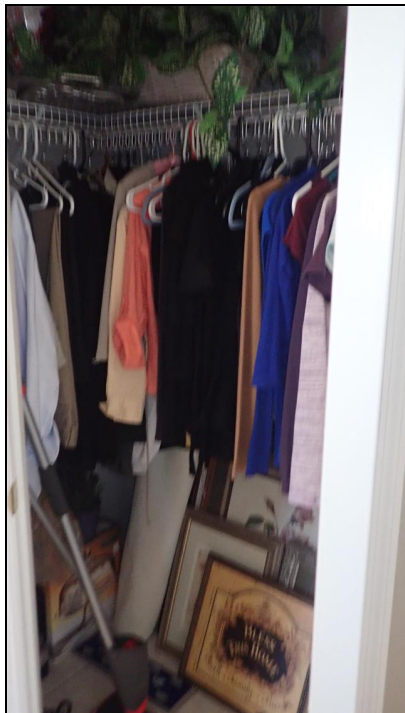
Personal goods stored in closets prevented access to inspection of all features contained in them. We suggest further inspection of these areas during your final walk through.

10.7 Item 1(Picture) Stored items in closet

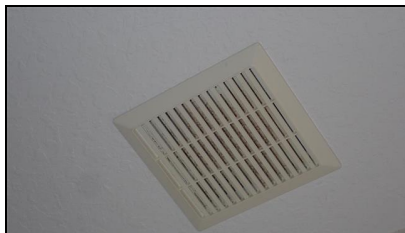
The bath vent covers and fan blades are covered with accumulated dust. Cleaning of the units will improve function.

12.7 Item 1(Picture) Clean bathroom vents

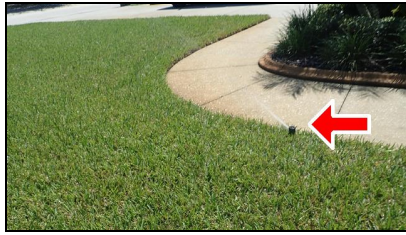
The sprinklers were operational at the time of inspection, however, typical maintenance and adjustment of the individual heads is required. Be sure that none of the heads spray on exterior house surfaces or mechanical equipment.

14.1 Item 1(Picture) Sprinklers ok
