Summary Only

Property Address:
123 America St
Tampa FL

**House 2 Home Inspections Services Inc.
Robert Erenberg
6225 Tigerflower Court
Land o Lakes, FL 34639**

This is not the complete home inspection report. It is only the Summary Items.

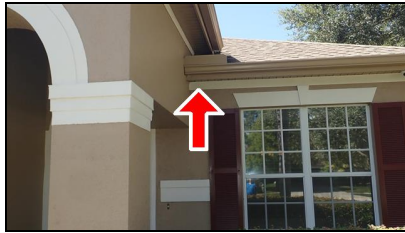
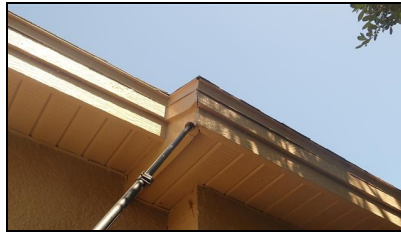
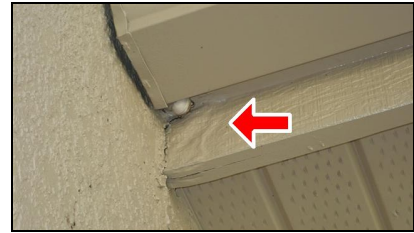
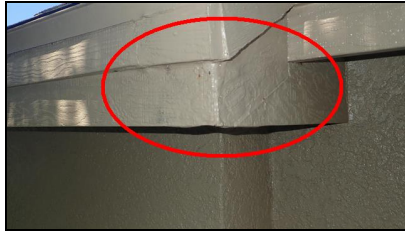
Repair the area of wood decay at the fascia boards at a few areas around the roof. We recommend you have a qualified technician further evaluate and advice. Replacement of affected materials is considered the best solution for long term performance of repair and plastic moldings are available for even better protection - (Contractor should review for additional damage and probe where suspect to insure that all damage is identified and replaced). Fillers are discouraged but are commonly used in repairs of smaller areas where replacement would be difficult. Fillers should be done by experienced tradesmen and warrantee for a reasonable length of time. Be sure to caulk, prime, and paint these areas once the repairs are complete to prevent recurrence and to match existing finishes.

3.10 Item 1(Picture) wood decay

3.10 Item 2(Picture) Wood decay

3.10 Item 3(Picture) Wood decay

3.10 Item 4(Picture) Wood decay

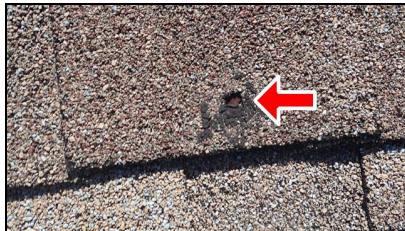
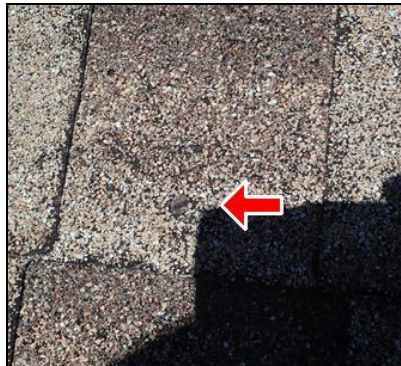
(2) There are a few scattered locations on the roof surfaces where the roofing nails in the shingles were either driven in crooked when installed or have started to back out of the roof sheathing due to changes in temperature and expansion and contraction of the materials. These nails are now "popping" through the shingle surface and repair is needed to prevent water intrusion and damage. Any exposed fastener is a leak source. The only practical cure (short of replacing the affected shingles) is to hammer down the nail and seal over the exposed fasteners. A qualified roofing contractor should do the job. The sealant typically needs to be monitored and renewed as needed to lessen the likelihood of leaks.

4.2 Item 7(Picture) Nail pop

4.2 Item 8(Picture) Nail pop

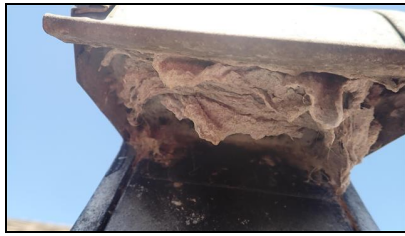
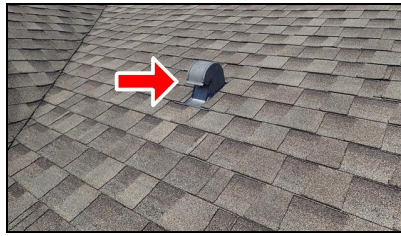
The dryer vent hood on the roof is very clogged with lint which is significantly restricting the air flow and operation of any vent flap. Have a professional duct cleaning service clean the hood, and since the vent has been restricted for an unknown period of time, they should also clean the entire vent system, flexible vent hose behind the dryer, and check the vent port on the dryer itself to insure that there is proper air flow and operation of the dryer and to eliminate a fire hazard. Then, be sure to clean and maintain the lint build-up from the dryer vent hood on a regular

13.3 Item 1(Picture) Clean dryer vent hood

13.3 Item 2(Picture) Clean dryer vent hood

basis (time between cleaning depends on individual use) to allow proper air flow and operation of the dryer. Improper maintenance of the dryer vent hood can create a fire hazard

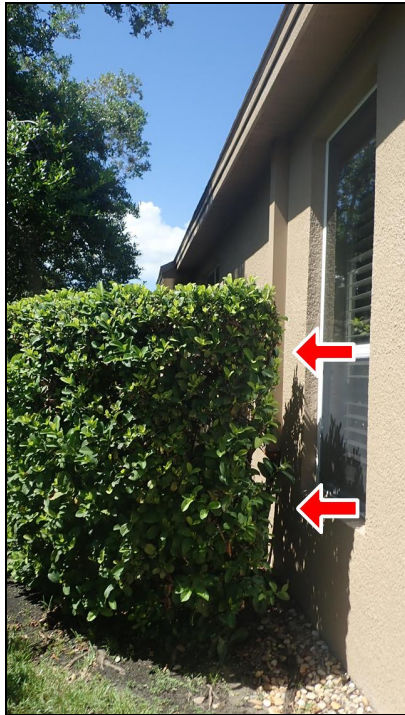
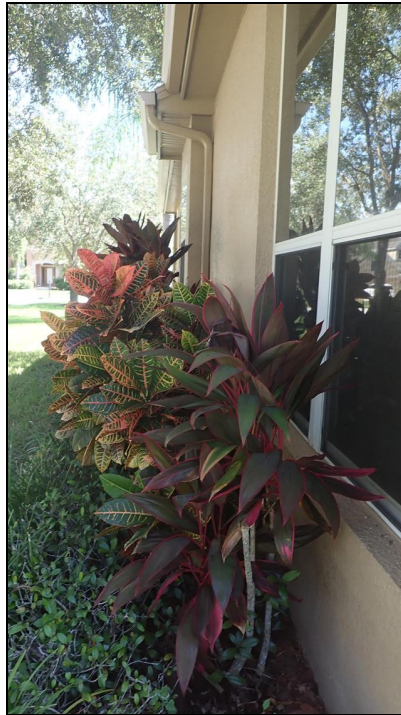
(1) The trees and shrubs on the property should be maintained to prevent overgrowth and encroachment onto and possible damage to the structure.

3.2 Item 1(Picture) Maintain shrubs trimmed back

3.2 Item 2(Picture) Maintain shrubs trimmed back

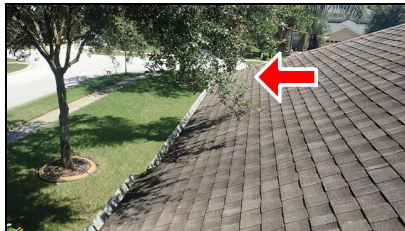
(2) Branches from the surrounding trees are overhanging the roof, or are in contact with the roof surface. This could damage (abrade) the roof surfaces and/or provide a route onto the roof and into the attic for insects and other pests. Nearby trees should be kept pruned.

3.2 Item 3(Picture) Trim back branches

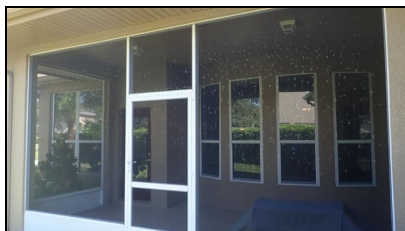
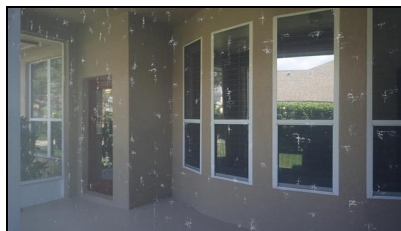
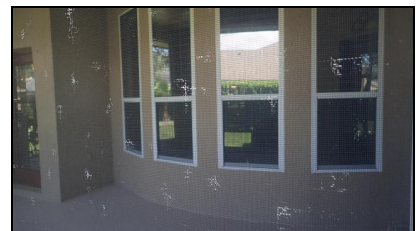
The screens at the rear patio have signs of some type of white debris stuck to them. We recommend you have a qualified technician further evaluate and clean as needed.

3.5 Item 1(Picture) Screened in rear patio

3.5 Item 2(Picture) DEbris on screens

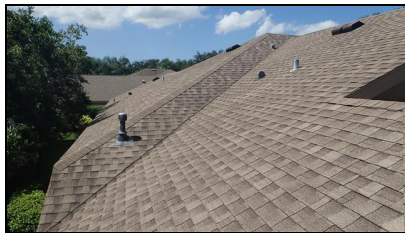
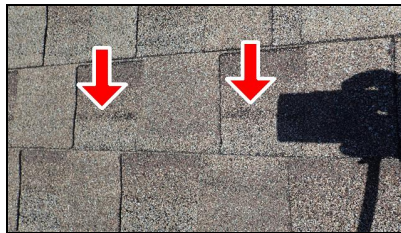
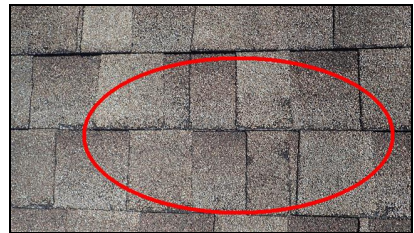
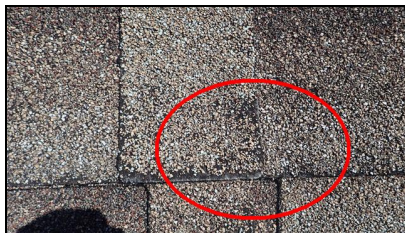
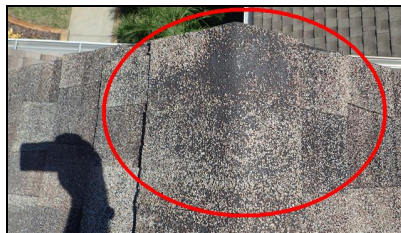
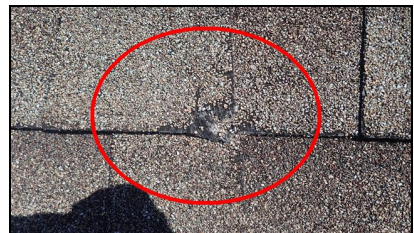
(1) The roof surfaces are showing some signs of age and appear to be past mid life. There is typical to heavy granular loss across the roof's surface. We recommend you have a qualified roofing technician further evaluate and advice on any necessary roofing repairs.

4.2 Item 1(Picture) Roof mid life

4.2 Item 2(Picture) Granular loss

4.2 Item 3(Picture) Granular loss

4.2 Item 5(Picture) Heavy granular loss at gable ridge

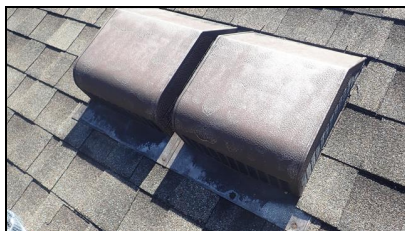
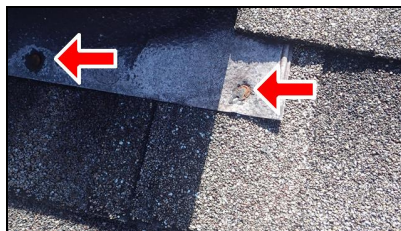
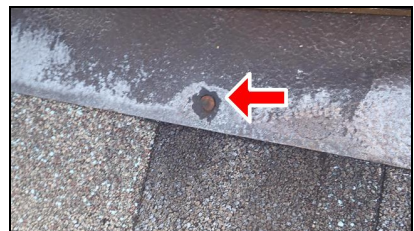
The nails that attach the off ridge vent to the roof are galvanized, however, many of the nails are already rusting and corroding. I recommend the application of roofing tar or silicone caulk over these nail heads to prevent them from corroding and so they will last the life of the roof.

4.5 Item 1(Picture) Off ridge vent

4.5 Item 2(Picture) Tar over ridge vent nails

4.5 Item 3(Picture) Rusted vent nail

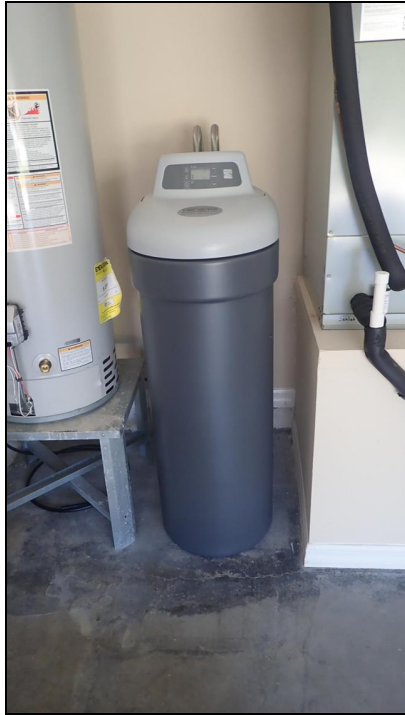
(3) Water treatment equipment (filter &/or softener) has been added to the main water delivery system. Evaluation of this equipment is outside the scope of this inspection. You should contact the company that installed or services the equipment, or if not available, contact a reputable water treatment company for evaluation and explanation of its features and benefits.

5.1 Item 1(Picture) Water softener beyond inspection

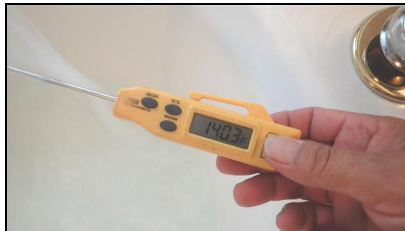
(2) The temperature on the water heater is turned up past the factory setting of around 120 degrees. The time to scald is significantly reduced as the temperature setting on the unit is increased. Also, if the temperature is turned up too high, it may cause leakage from the temperature and pressure relief valve. Upon ownership, you should evaluate and adjust the temperature setting on the water heater to meet your personal needs and to maximize energy efficiency and personal safety.

5.8 Item 2(Picture) Water temperature above 120 degrees

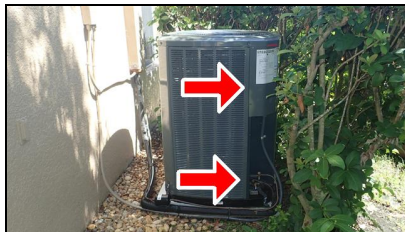
The shrubs are too close to the air conditioning condenser unit. These units require adequate airflow across the coils to efficiently exchange temperature from the warmed refrigerant as it passes through the tubing inside. Vegetation that is allowed to grow too close to or onto the condenser housing impedes airflow, and can contribute to damage and inefficient operation of the system. Vegetation should be kept trimmed back at least 12 inches away from all sides of the condenser housing.

7.2 Item 1(Picture) Trim back shrubs

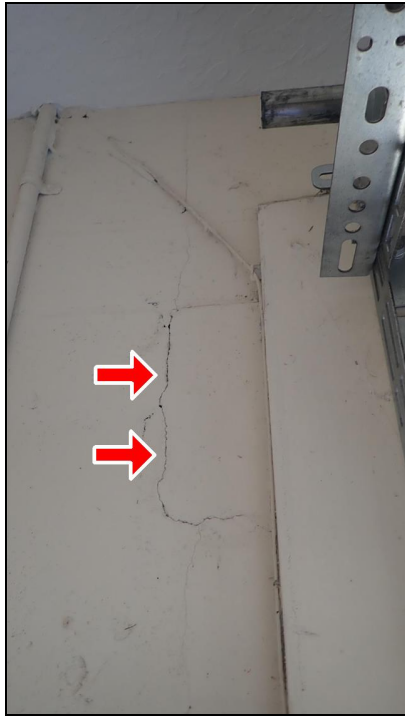
Minor cracking is evident in the garage wall, but there is no noticeable vertical displacement or evidence of significant settlement. The crack appears to be typical for this type of construction.

9.7 Item 1(Picture) Typical crack at garage wall

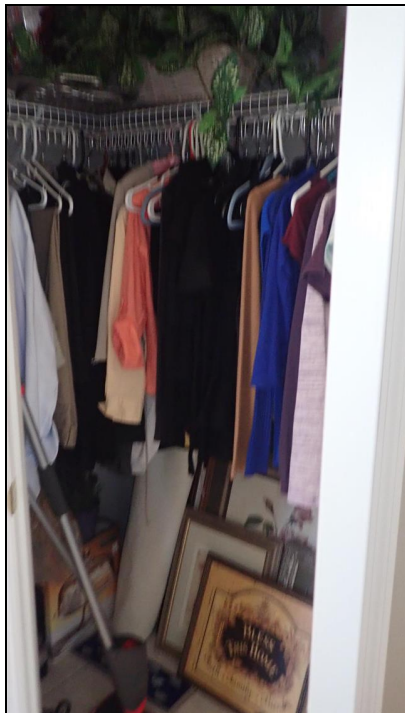
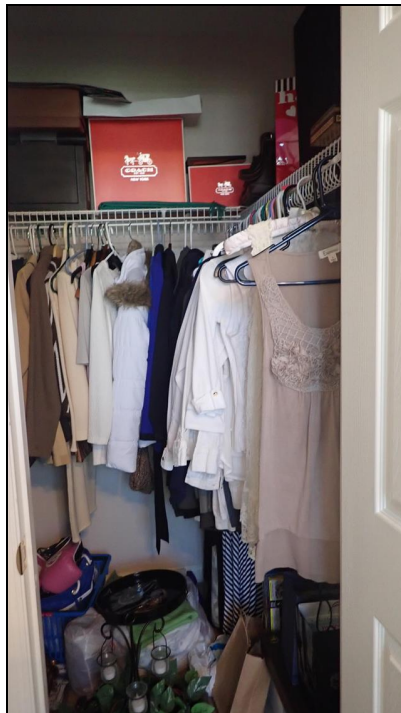
Personal goods stored in closets prevented access to inspection of all features contained in them. We suggest further inspection of these areas during your final walk through.

10.7 Item 1(Picture) Stored items in closet

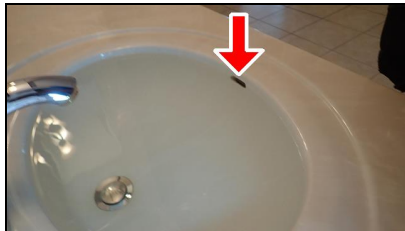
The overflow drain on the wash basin is clogged. The drain should be cleared. A qualified technician could do the work.

12.2 Item 1(Picture) Clogged over flow

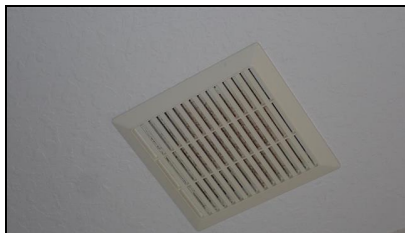
The bath vent covers and fan blades are covered with accumulated dust. Cleaning of the units will improve function.

12.7 Item 1(Picture) Clean bathroom vents

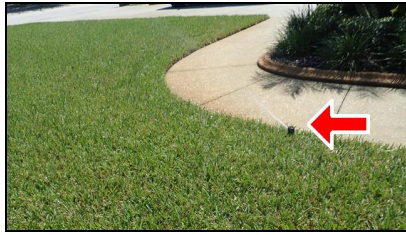
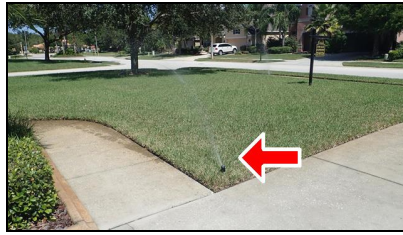
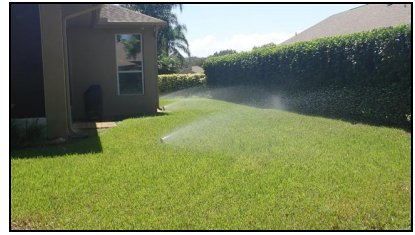
The sprinklers were operational at the time of inspection, however, typical maintenance and adjustment of the individual heads is required. Be sure that none of the heads spray on exterior house surfaces or mechanical equipment.

14.1 Item 1(Picture) Sprinklers ok

14.1 Item 2(Picture) Sprinklers ok
