Inspection Report

Property Address:
123 America St
Tampa FL

House 2 Home Inspections Services Inc.

Date: 9/27/2018	Time: 01:30 PM	Report ID: 20180927-3023-Northfield-Dr
Property: 123 America St Tampa FL	Customer:	Real Estate Professional:

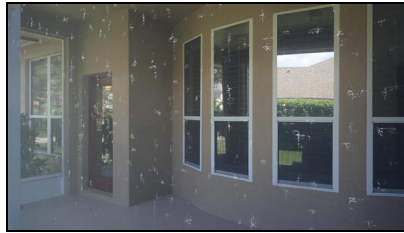
3.5 The screens at the rear patio have signs of some type of white debris stuck to them. We recommend you have a qualified technician further evaluate and clean as needed.

3.5 Item 2(Picture) DEbris on screens

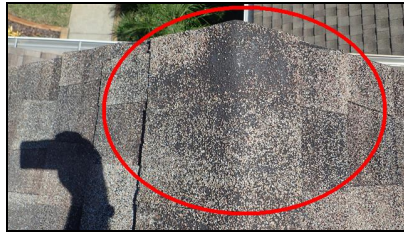
4.2 Item 5(Picture) Heavy granular loss at gable ridge

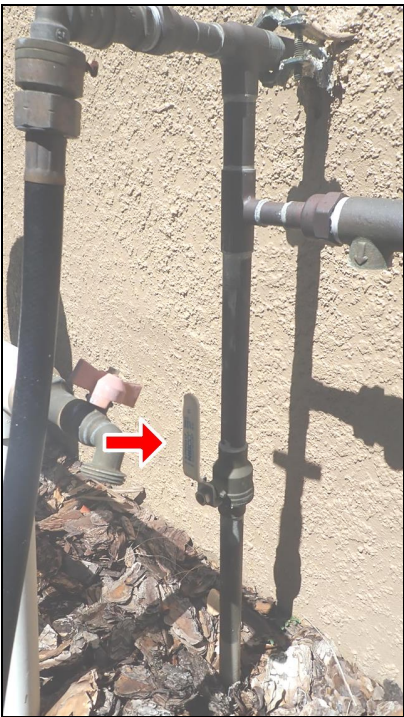
5.2 The main water shut off valve for the home is located on the South exterior side of the garage.

5.2 Item 1(Picture) Main water supply shut off valve

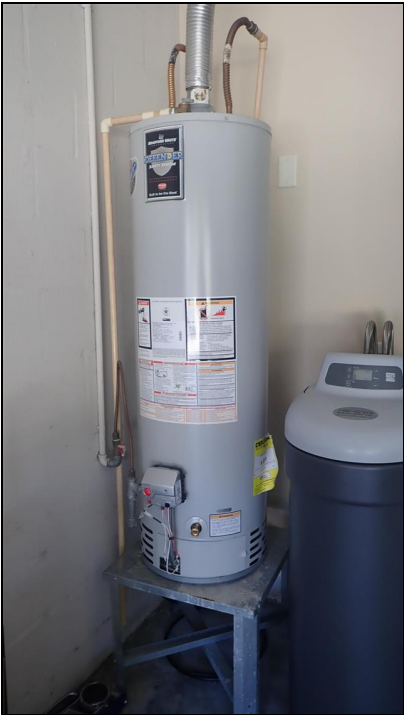
5.8 (1) The water heater and associated components are operational and in good condition at this time.

5.8 Item 1(Picture) Water heater
ok

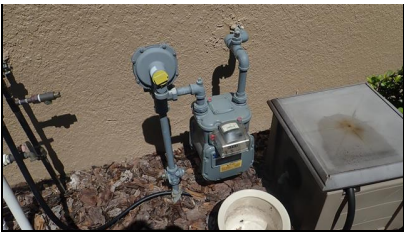
5.11 The gas shut off valve is at the meter on the South side of the house.

5.11 Item 1(Picture) Gas meter

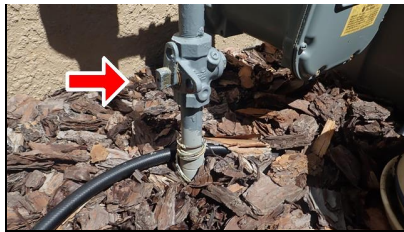
5.11 Item 2(Picture) Gas meter
shut off valve

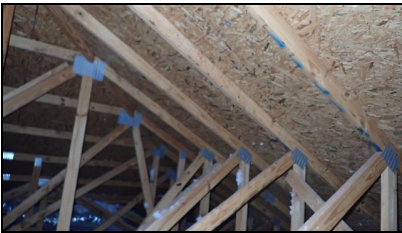
8.5 No leaks, stains, or moisture related issues were evident within readily visible and accessible areas.

8.5 Item 1(Picture) No stains

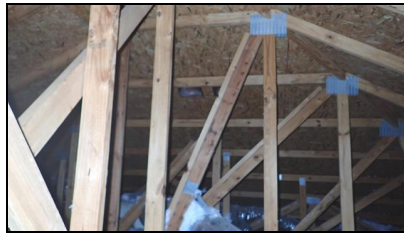
8.5 Item 2(Picture) No moisture stains

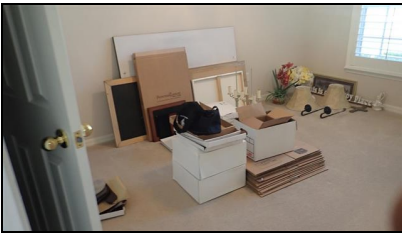
10.1 Item 1(Picture)

10.1 Visual inspection of the interior areas, closets, cabinets was limited by stored items and furnishings. If any significant defects are found at the pre-closing walk though, once the house has been vacated, contact me so I can evaluate the items to protect your interests.

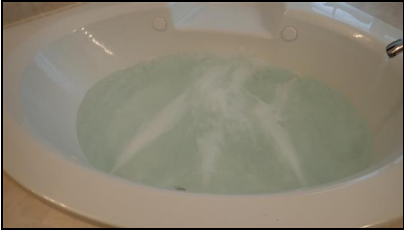
12.11 The whirlpool tub was filled and turned on with the user controls. It is in adequate condition, other than any exceptions noted.

12.11 Item 1(Picture) Tub ok

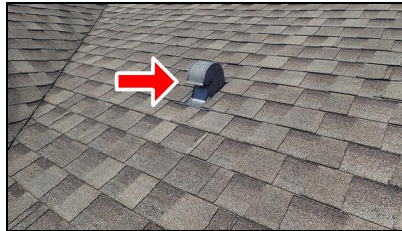
13.3 Item 2(Picture) Clean dryer vent hood

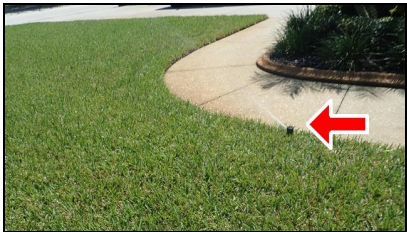
- 14.0 Regular routine maintenance of irrigation system should be anticipated and performed. Maintaining the sprinkler heads and monitoring for proper coverage will ensure peak performance of the system.
- 14.1 The sprinklers were operational at the time of inspection, however, typical maintenance and adjustment of the individual heads is required. Be sure that none of the heads spray on exterior house surfaces or mechanical equipment.

14.1 Item 1(Picture) Sprinklers ok

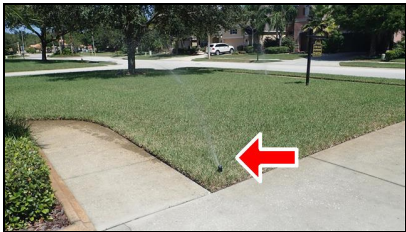
14.1 Item 2(Picture) Sprinklers ok

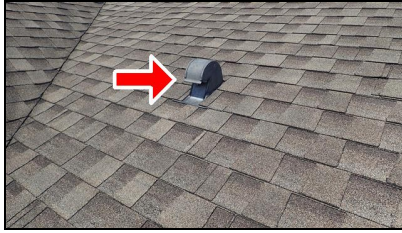
13.3 Item 2(Picture) Clean dryer vent hood

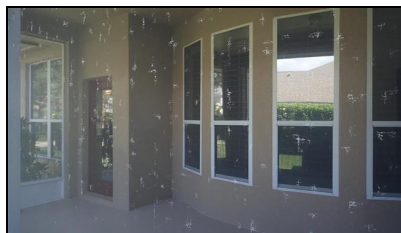
3.5 Item 2(Picture) DEbris on screens

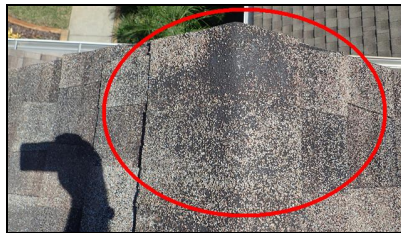
4.2 Item 5(Picture) Heavy granular loss at gable ridge

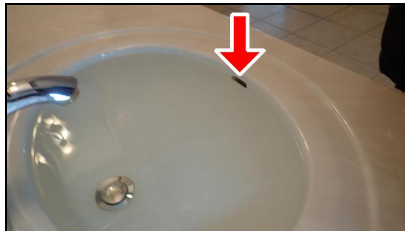
The overflow drain on the wash basin is clogged. The drain should be cleared. A qualified technician could do the work.

12.2 Item 1(Picture) Clogged over flow
